Subject: Asbestos and Hazardous Materials Survey
Project Number BE-0157-A
7th Avenue Property
710 7th Avenue South
Seattle, WA 98104

Asbestos and Hazardous Materials Survey

**7th Avenue Property
710 7th Avenue South
Seattle, WA 98104**

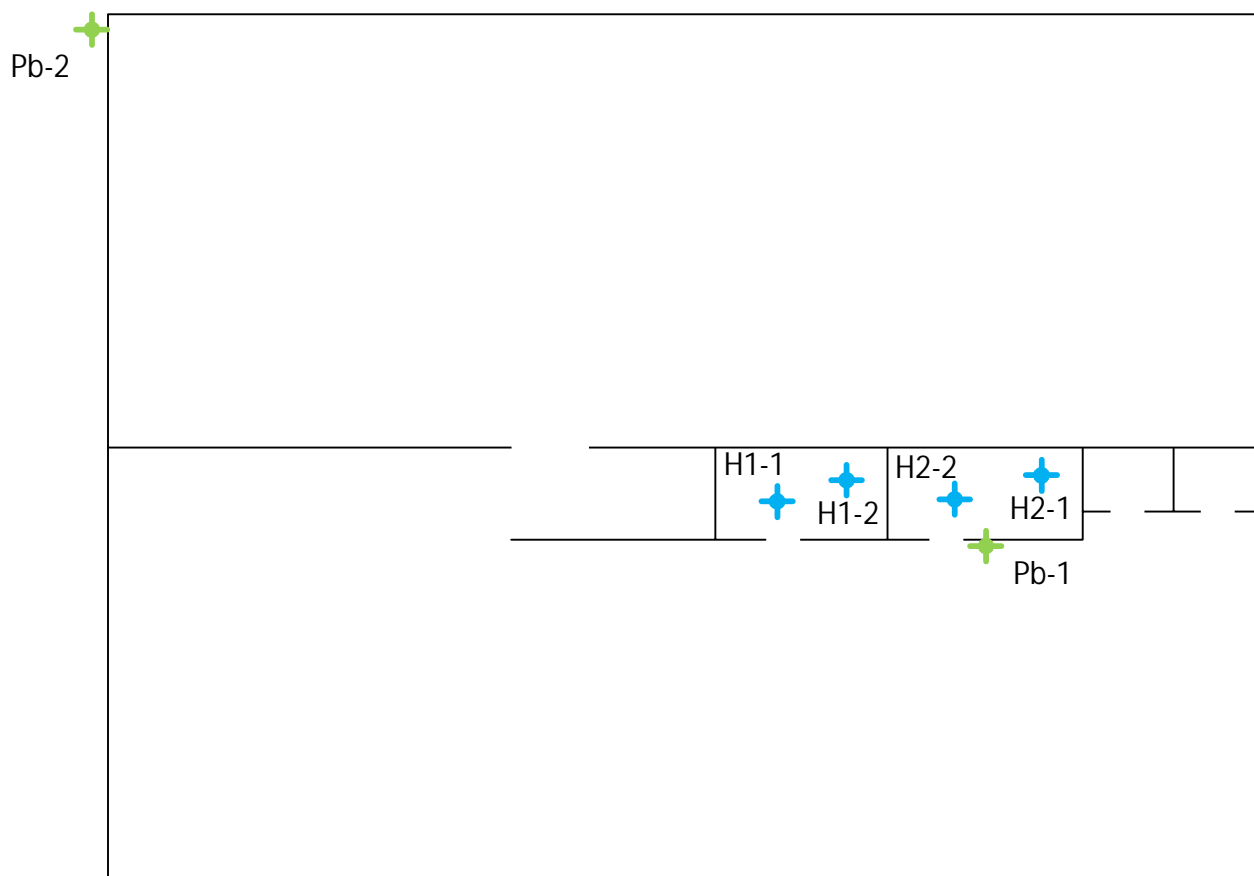
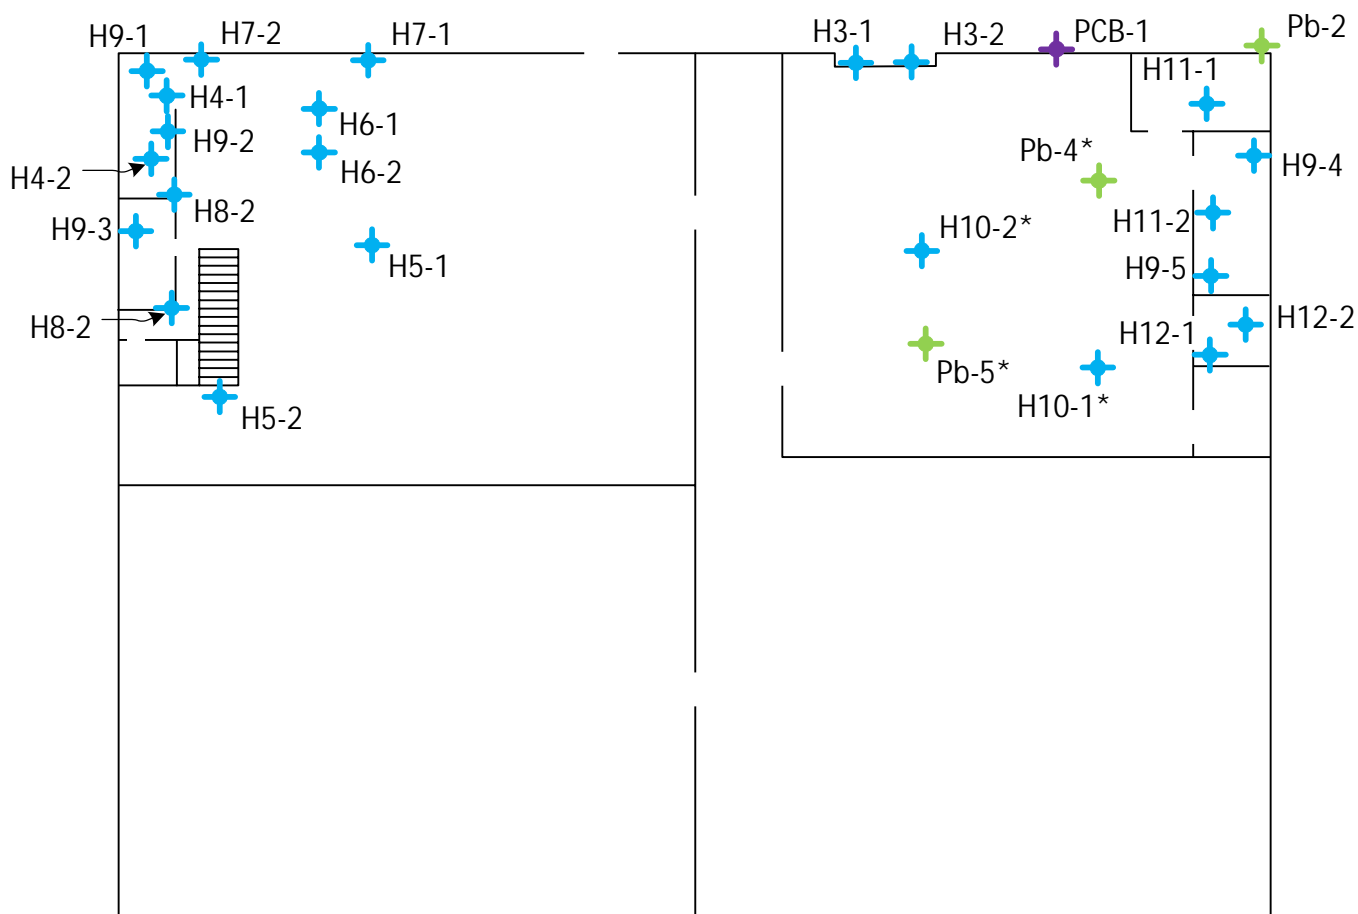
The estimated quantity of these ACM is provided on Table 1. See Figure 2 for Building orientation and sampling locations.
